# ESTCP Cost and Performance Report

## Field Demonstration of a Novel Biotreatment Process for Perchlorate Reduction in Groundwater

December 2010

Project: ER-200636

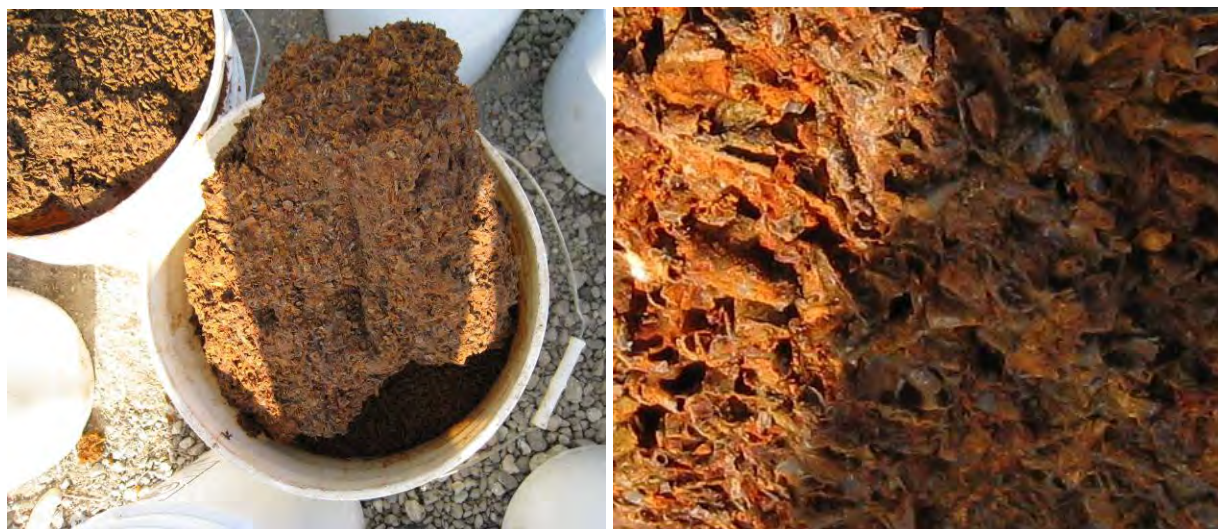
The most plausible reason for the bioreactor upset was a hydraulic problem within the bed, causing significant short circuiting of the water and poor contact between the water and the ZVI-supported bacteria. It is also possible that combination of effects, e.g., short-circuiting combined with localized passivation of the iron played a role in the upset.

When the bioreactor was decommissioned, visual observation of the bed was conducted. Initially, the ZVI bed was a highly porous packed bed; over time, it was converted to a solid and compact mass of iron and iron corrosion products. Large blocks of ZVI with low porosity and permeability were glued together by corrosion products (Figure 7). This is likely to have led to preferential paths, consistent with the hypothesis that the performance problems were the result of hydraulic problems within the bed.

**Figure 7. Pictures of large blocks (left) of ZVI taken out of the reactor when it was dismantled showing the solid structure of the ZVI bed, and close view (right) of ZVI showing the deposits of iron corrosion products and quasi total loss of porosity.**
